GENERAL ARTICLE

The effects of cyclones, tsunami and earthquakes on built environments and strategies for reduced damage

R.S. Mallawaarachchi* and C. Jayasinghe

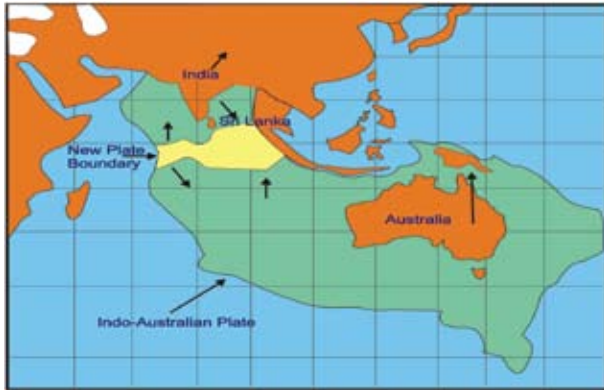
Figure 1: Major tectonic plate settings of the India-Australia region. Recent studies reveal that Indo-Australian plate has separated many millions years ago and now they act as two separate plates. The Australian plate is rotating in the counter clock wise direction by putting stress on the Southern segment of the Indian plate and Western section of Burma micro plate making this triple point tectonic junction a very active seismic area.

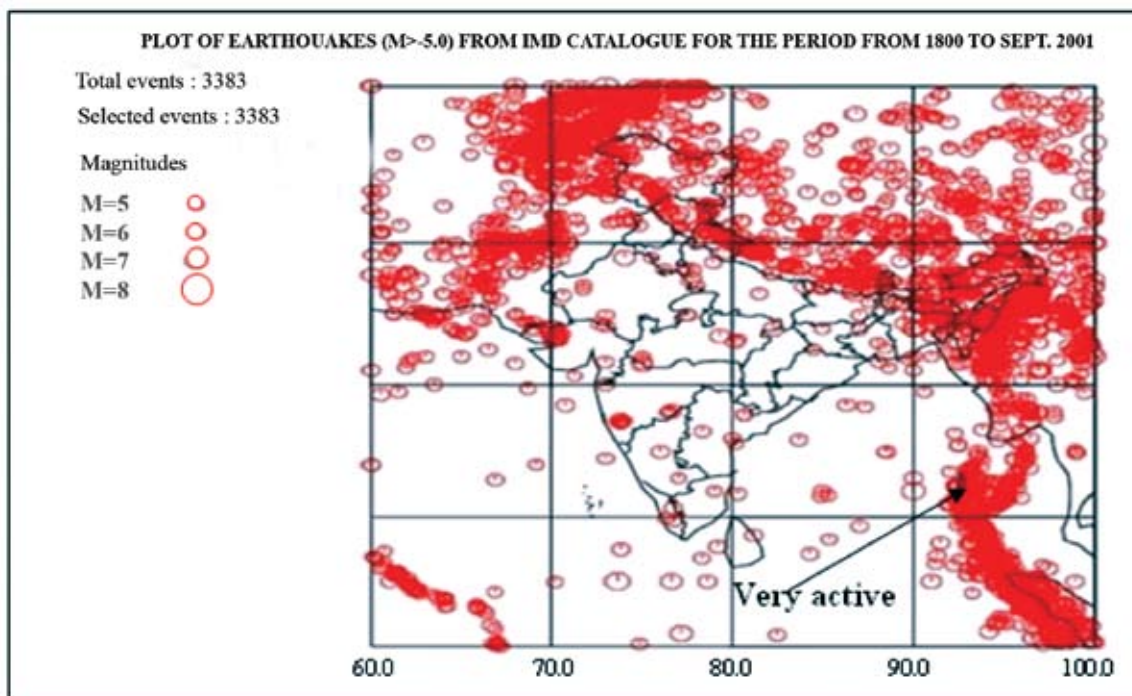
Figure 2: Seismicity in the Northeast Indian Ocean region for the period from 1800 to Sept. 2001. Each dot indicates an earthquake of magnitude greater than 5M in Richter scale Magnitudes are represented by the sizes of the dots.

seismic areas in the world today as shown in Figure 2. When earthquakes of higher magnitudes (generally, the magnitude greater than 6.5 in Richter scale) occur within the ocean, there is a strong possibility for tsunami of some magnitude.

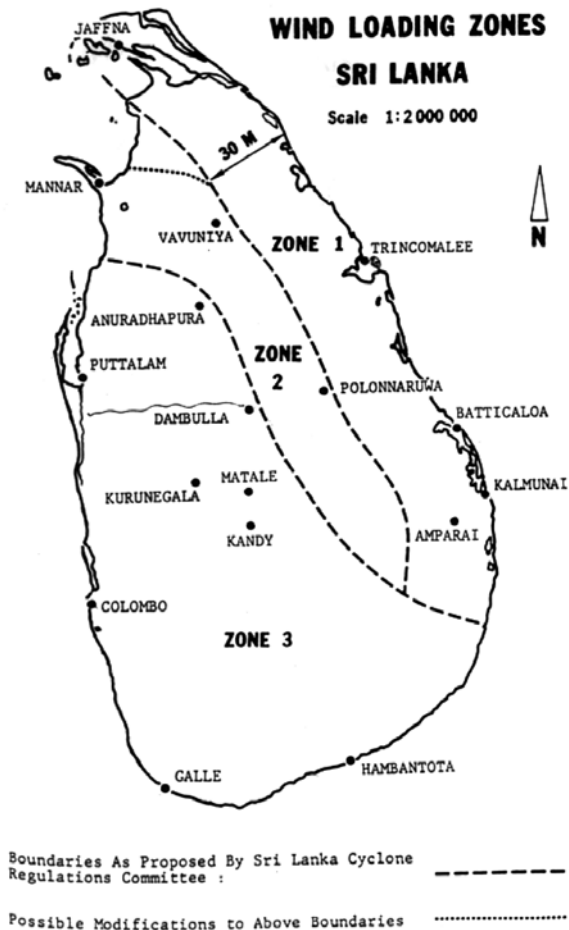
Figure 4: Wind loading zones in Sri Lanka⁸, Scale 1:2 000 000

Zone 1 can be identified as the area where major towns like Jaffna, Trincomalee, Batticaloa, Kalmunei, Amparai are located and the area within a 50 km band from the eastern coastal line. Zone 3 consists of all towns west of Puttlam, Anuradhapura, Dambulla, Matale, and Kataragama. The major towns like Colombo, Kandy, Kurunegala, Galle, Matara, Nuwara-eliya and Bandarawela also fall within Zone 3. Zone 2 includes

the rest of the areas between Zones 1 and 3⁷. Figure 4 indicates the three different wind zones in Sri Lanka⁸.

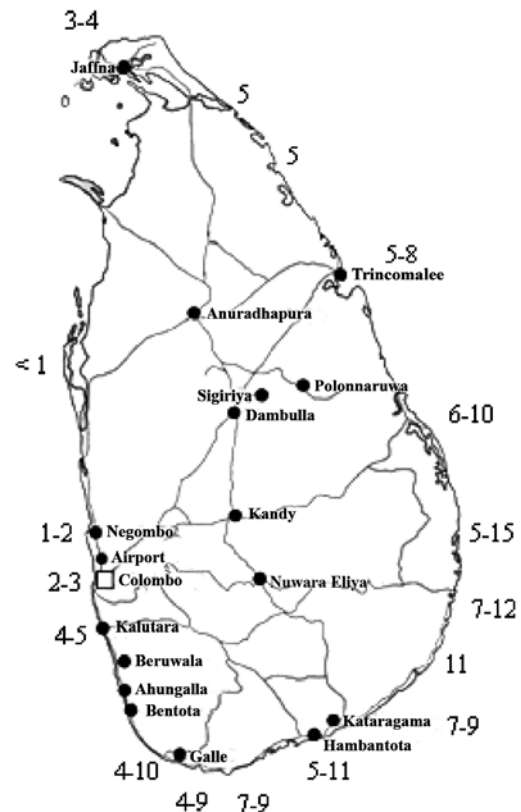
Figure 5: Recorded tsunami wave heights in meters [12]

the typical structural damages were due to wave heights of less than 15 m. In many places the wave heights were within the range of 2-5 m from the structural foundation levels¹³. Figure 5 shows the estimated wave heights from the mean sea level in the tsunami affected coastal areas in Sri Lanka.

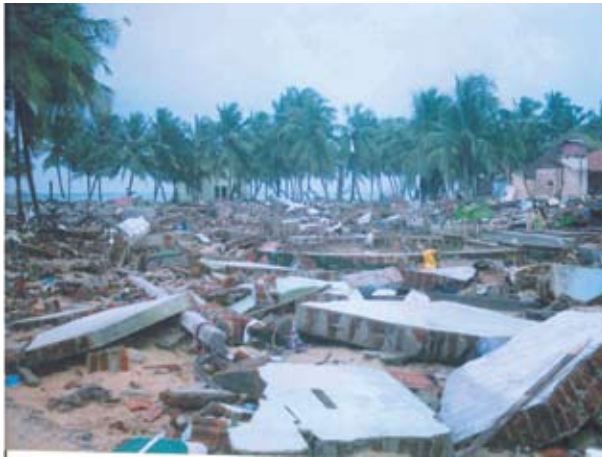
Figure 6: Completely collapsed brickwork structures due to tsunami tidal waves in Kalmunei

Figures, 6, 7, and 8 show some of the common structural damages that occurred after the tsunami waves. According to previous studies¹⁵, the types of failures in these kinds of non-engineered structures are mainly due to the lateral pressure exerted on walls from filled up water, uplift caused by filled up water, floor slab failures due to erosion of foundations and also due to liquefaction of sandy soils under the foundations.

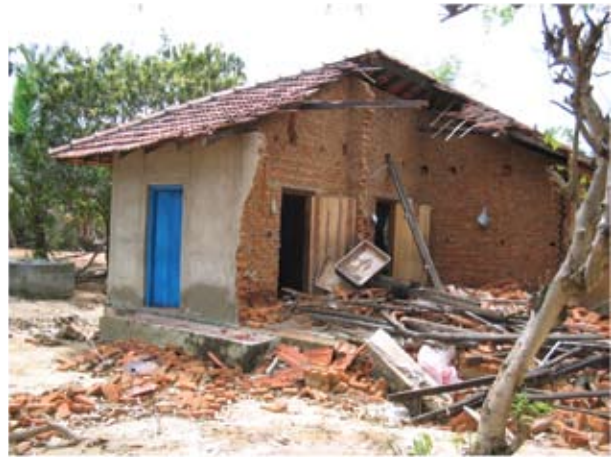
Figure 7: Partially collapsed brickwork structures due to tsunami tidal waves in Sri Lanka

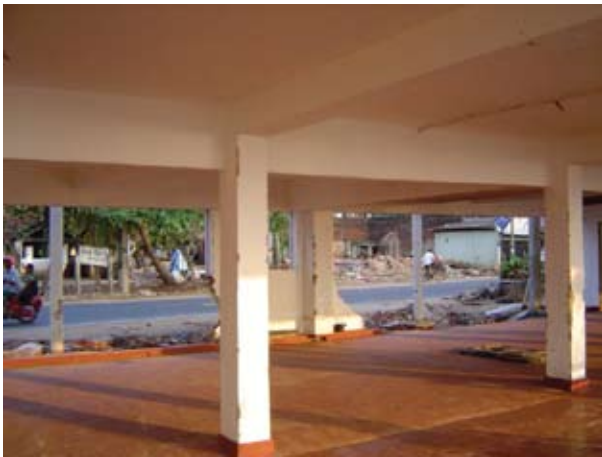
Figure 8: A structure of a building survived with minimum damage. Only the infill masonry panels have collapsed from tsunami waves

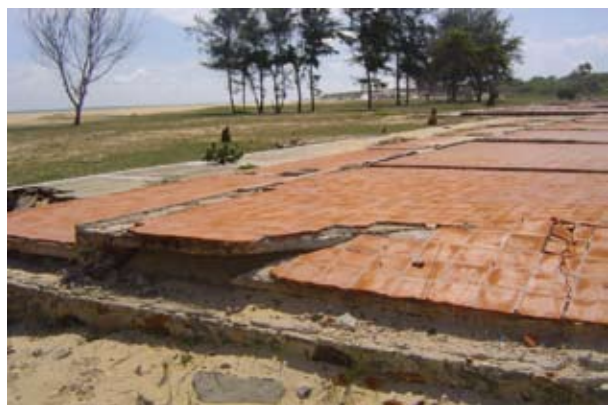
Figure 9: Failure of a masonry low rise building in Yala-Safari Beach Hotel, Yala, due to tsunami waves

In some cases where the foundations were rigid enough, the wall panels have completely washed away due to inadequate bond between walls and the plinth beam when subjected to excessive lateral loads. Figure 9 shows a picture of a damaged single storey masonry building in which all the walls have washed away from tsunami tidal waves.

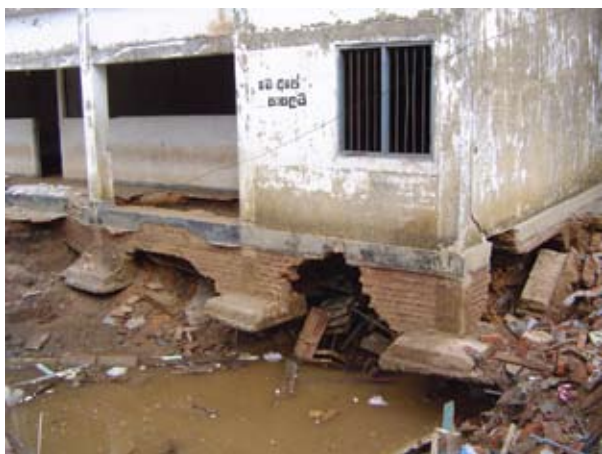
Figure 10: Under-scouring of foundation at a corner of a school building from tsunami waves

level. Figure 10 shows a picture of a school building with isolated pad footings. It shows how severe the scouring action can be at a corner of a building like this due to the formation of eddies in waves.

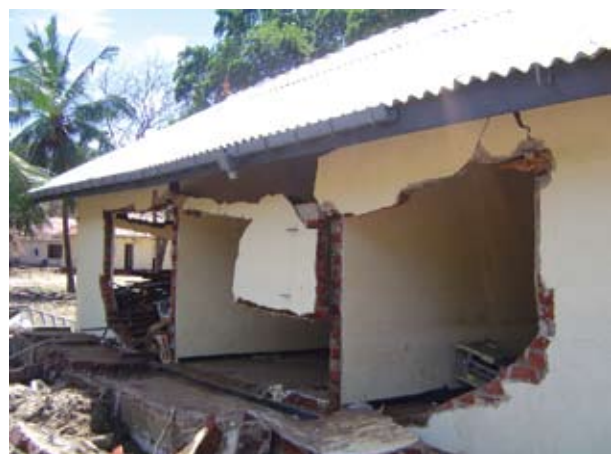
Figure 11: A house close to the shoreline, its long weaker side facing the sea coast

The orientation of the building also plays a major role with respect to the structural performance. In case of heavy and gusty winds, frequent floods, and tsunami waves, it is more desirable to have the shorter or the stiffer edge facing them. Figures 11 and 12 provide some evidences on the effect of orientation of a building against its structural performance under excessive loading conditions. Both these houses were close to the shore line. The house where the front wall with many openings facing the sea, (shown in Figure 11) suffered severe damage. In the house shown in Figure 12, the short and stiffer walls well supported by walls located perpendicular to it, suffered much less damage. This indicates that the enhanced lateral load resistance is highly beneficial in resisting lateral loads that occur in extreme events of nature.

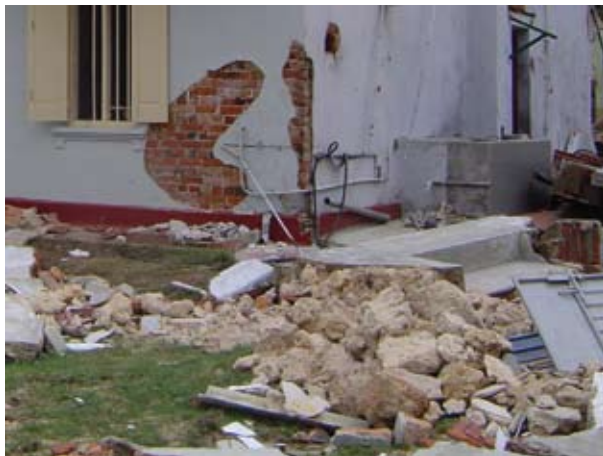
Figure 12: A house close to the shoreline, its short and stiffer edge facing towards the sea

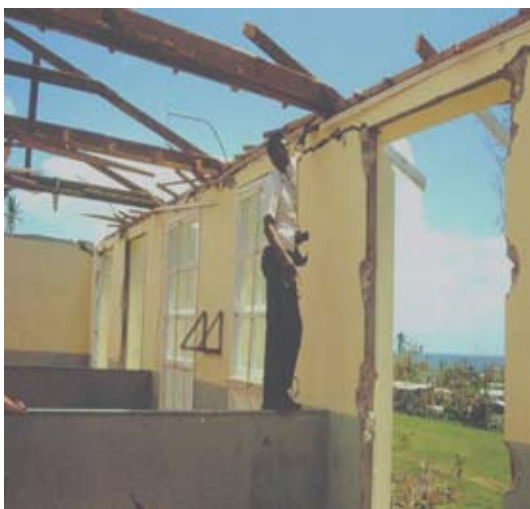
Figure 13: Single storey building; asbestos roof has blown away due to a cyclone

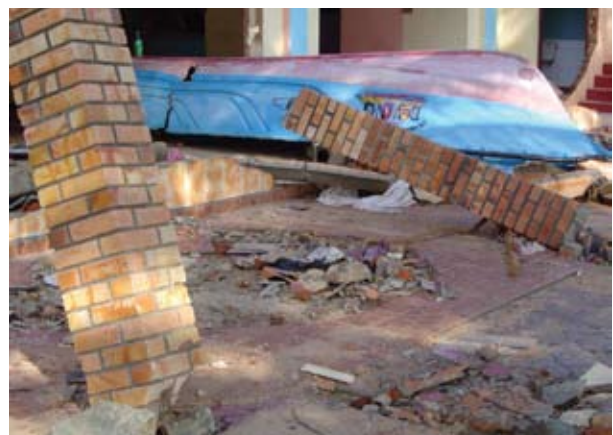
Figure 14: Damage due to a boat taken from tsunami waves

Floating debris can cause severe damage during flooding, cyclonic and tsunami situations. Part of the debris is due to damaged buildings and hence ability to minimize damage could assist in reducing such damage. However, there can be other objects which can come and hit along with water or wind such as the boat shown in Figure 14. These things can cause serious structural damage due to impact loading.

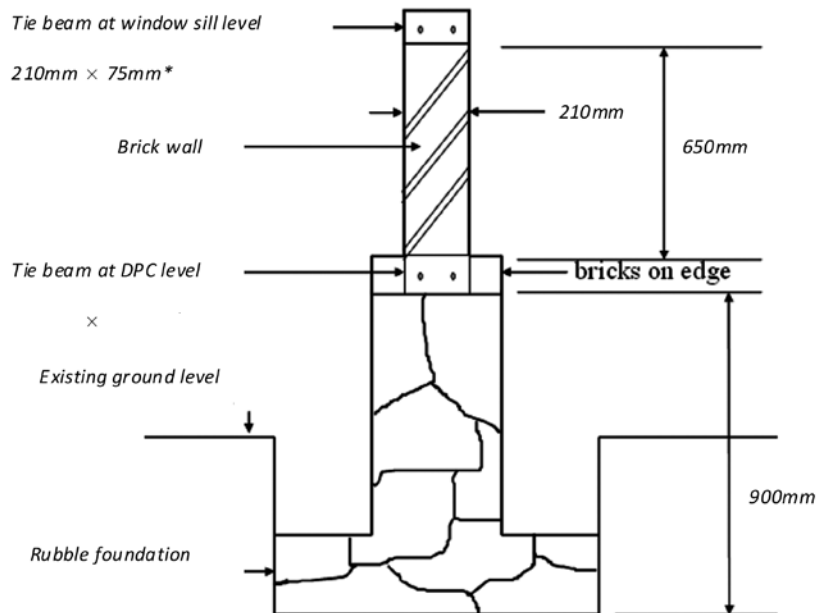
Note: * Grade of concrete C20 (i.e. cement:sand:coarse aggregate=1:2:4)
 * Reinforcement for tie beams 2T10

Figure 15: Rubble foundation with tie beams at DPC (Damp proof course) and window sill levels

When reduction in foundation bearing capacities are anticipated, it is important to ensure that the foundation will be strong enough to transfer loads from weaker regions to stronger regions until the soil regains the strength. This could be achieved by providing a continuous tie beam at the window sill level which acts in conjunction with the tie beam at plinth level and the foundation rubble work, to minimize the local deformations and hence cracking of walls. An arrangement of the proposed foundation system is shown in Figure 15.

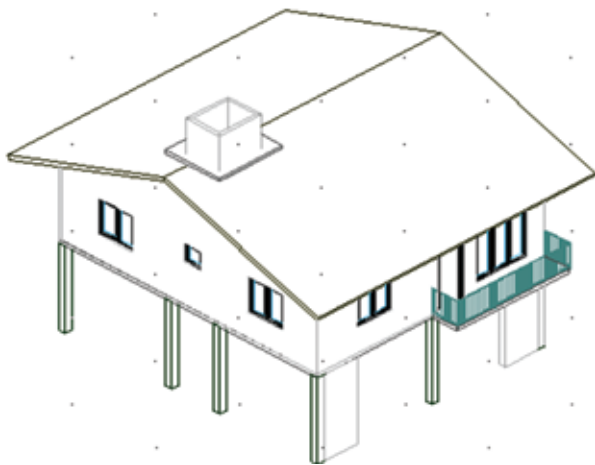
Figure 16: An elevated house which is suitable for low lying flood prone areas and coastal areas.

Another option available is the construction of elevated houses using a suitable arrangement of reinforced concrete columns as shown in Figure 16. However, this will have a significant increase in cost for a single storey house. This house will need sufficient number of brick walls to provide lateral stability needed against lateral loads induced by earthquakes. As shown in Figure 17, this type of localized effect can be expected from earthquake induced base shear forces. This picture was taken at Beralihela, Tissamaharamaya after few earthquake tremors on 9th, 20th and 21st July 2007.

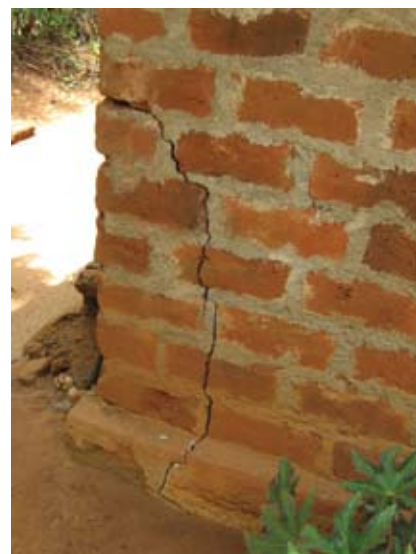
Figure 17: A masonry house subjected to earthquake induced ground motion- Beralihela, Tissamaharama
