RESEARCH ARTICLE

Resistivity imaging and self-potential applications in groundwater investigations in hard crystalline rocks

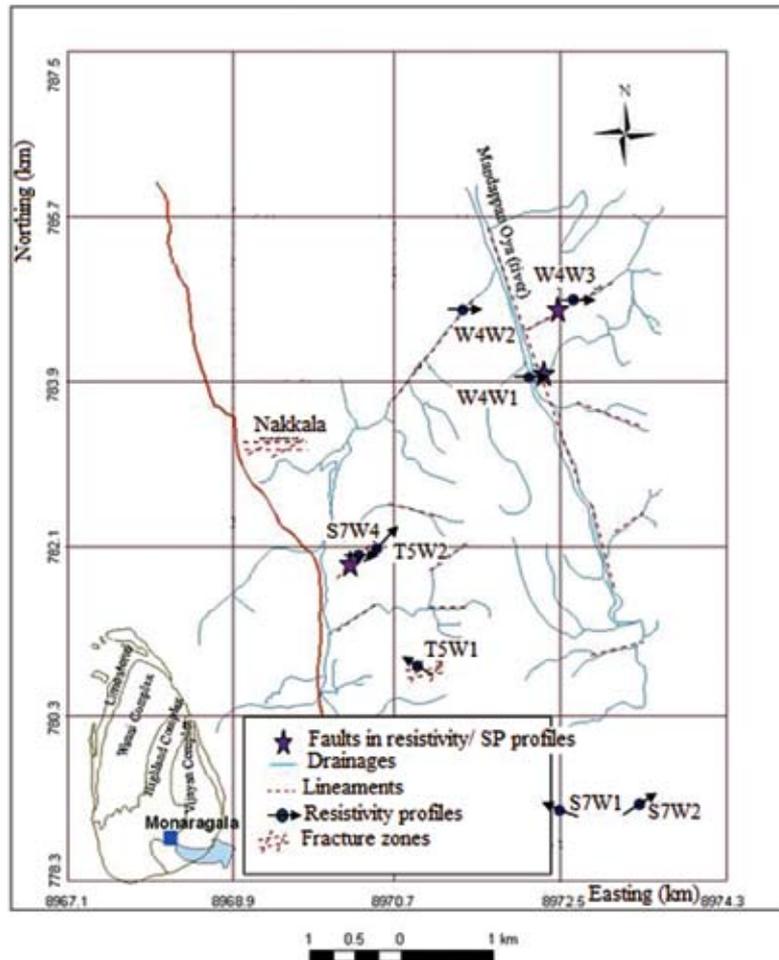
Figure 1: Survey locations of resistivity imaging and self-potential (Faults, lineaments and fracture zones identified by geological and topographic maps and aerial photographs are also shown. The grid lines are given as kilometres east of the Greenwich meridian and north of the equator.)

The location chosen for this study was Moneragala (6° 52' 0N, 81° 20' 60E, altitude 157 m) in the Southeast of Sri Lanka as shown in Figure 1, where there is severe shortage of water, and no major rivers or river diversion schemes (even in the planning stage).

As the regional geology and geomorphology are key indices in locating groundwater reserves in a given area, the geological maps, topographic maps and aerial photographs were studied prior to investigations to identify the most favourable sites for groundwater. The most probable areas of fracture zones, faults, drainages and lineaments were identified by interpretation of the above maps and images. The results are shown in the map in Figure 1.

To measure the self potential, a multi-meter with sufficiently high input impedance was connected to electrodes driven some 10-15 cm into the ground and read off. A normal potentiometer circuit was not used as it tends to reduce short and long wave telluric disturbances with a reduction in appropriate field measurements¹⁸. To avoid zero errors, one electrode was fixed whilst moving the other electrode. Both the resistivity imaging method and self potential method were applied in parallel at selected locations as shown in Figure 1. The resistivity imaging survey was carried out with 5 m electrode spacing and penetration up to 20 m instead of 10 m spacing, due to instrumentation malfunctioning in the field. A total number of eight resistivity imaging profiles were carried out together with eight parallel SP profiles as can be seen in Figure 1 in the study area.

The results of faults, fracture zone and lineaments obtained from aerial photographs and geological / topographical map interpretations are indicated in Figure 1. Results obtained from resistivity imaging and self potential methods are shown in Figures 3 - 18. As can be seen from the resistivity images, a wide range of resistivities ranging from about 25 ohm.m to about 5000 ohm.m are shown on the resistivity image profiles, indicating areas of hard rocks (with a resistivity value approaching 5000 ohm.m) to areas of possible groundwater accumulations (with a resistivity of 10 – 100 ohm.m). Self-potential surveys were conducted to compliment and confirm the results obtained from resistivity images.

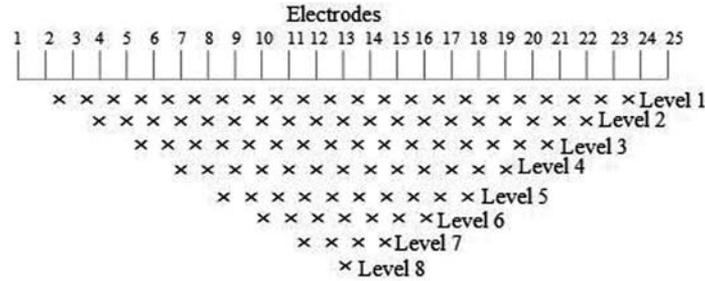
Figure 2: Electrode setup and measurement sequence for building up a pseudosection⁹

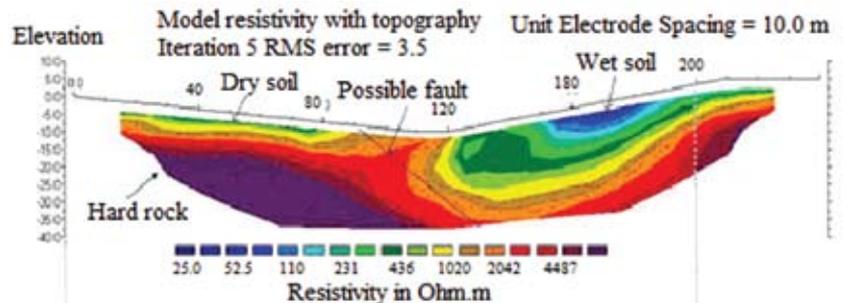
Figures 3 and 4: Resistivity image and SP survey profile respectively for transect W_4W_1

The resistivity image for transect W_4W_1 shown in Figure 3 was conducted across the Mandappan Oya (stream). The results suggest a possible fault structure (Figure 3) as seen in the structural map of the area as well (Figure 1). Rocks with high resistivity were observed at upper left area of the profile (from a distance of 0 m to about 80 m). These high resistivities are shown on the right side of Figure 3 at a depth of more than 40 m which suggests

vertical displacement of the rocks with high resistivity along the fault plane. The low resistivities at the upper right area at a distance of about 180 m in the profile possibly suggest groundwater accumulations.

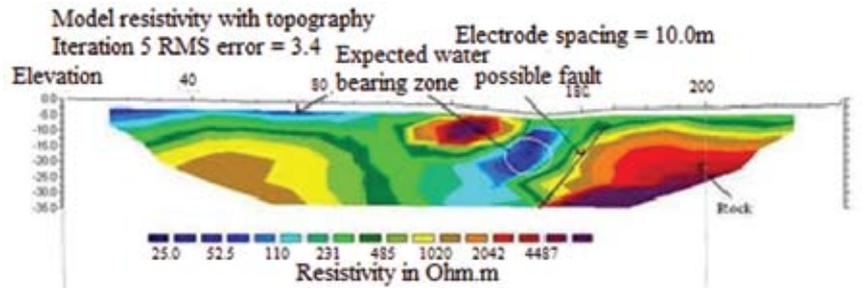
Figure 5

Figures 5 and 6: Resistivity image and SP survey profile respectively for transect W_4W_2

The resistivity image profile for transect W_4W_2 shows significant, well-defined geological features (Figure 5). At a distance of about 160 m, a possible fault approximately 60° towards the upper right in the profile can be inferred. This fault was clearly seen along the branch of Madappan oya in the geological map (Figure 1). A low resistivity zone at a distance of about 140 m possibly indicates groundwater accumulation at a depth of 15 m from the surface.

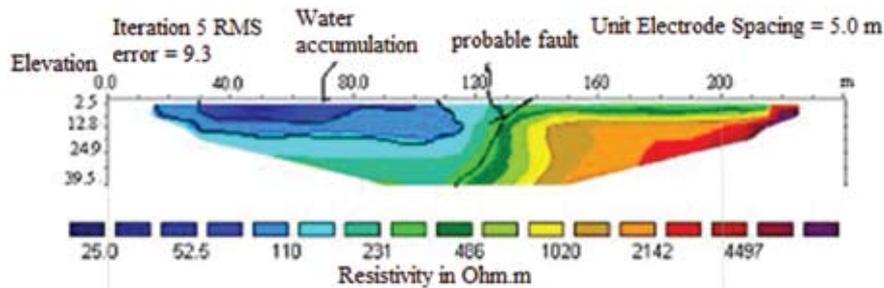
Figure 7

Figures 7 and 8: Resistivity image and SP survey profile respectively for transect W_4W_3

The resistivity imaging profile for transect W_4W_3 indicates a directional fault (Figure 7) below the 13th electrode at a distance of about 120 m. A directional fault was identified around the same location in the geological and structural map. Figure 8 (which shows the SP anomalies for transect W_4W_3), indicates negative anomalies at the centre of the profile at a distance between 25-120 m thus tallying well with the low resistivity values of the resistivity image. It must be noted that

water accumulations are not indicated near the probable fault, as it is unlikely that water will accumulate near the fault since it is almost a vertical one.

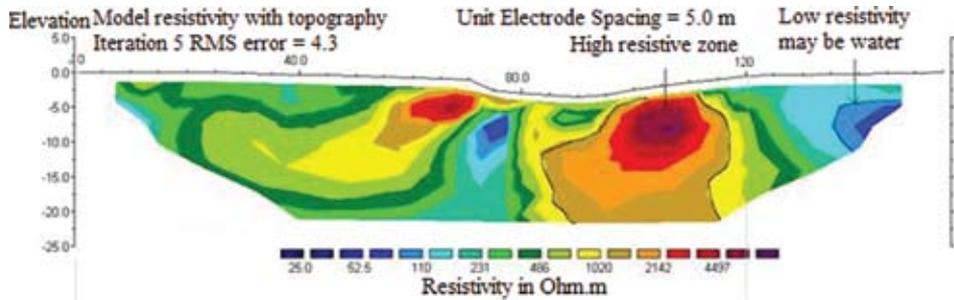
Figure 9

Figures 9 and 10: Resistivity image and SP survey profile respectively for transect T_3W_1

Transect T_5W_1 was selected to investigate a structurally fractured zone in the area, as identified by aerial photographs. The resistivity image for the transect (Figure 9) has two high resistivity zones separated by low resistivities. The high resistivity zone on the left side of the profile is restricted to shallow depth, possibly representing a hard rock boulder overlying soils with low resistivity. The high resistivity zone on the right side of the profile at a horizontal distance of about 80 – 120 m stretches deeper, indicating a possible extension of the basement rocks.

The low resistivity zone in Figure 9, sandwiched between two high resistivity zones, possibly indicates the existence of a weak geological structure, which is favourable for the accumulation of groundwater. Two

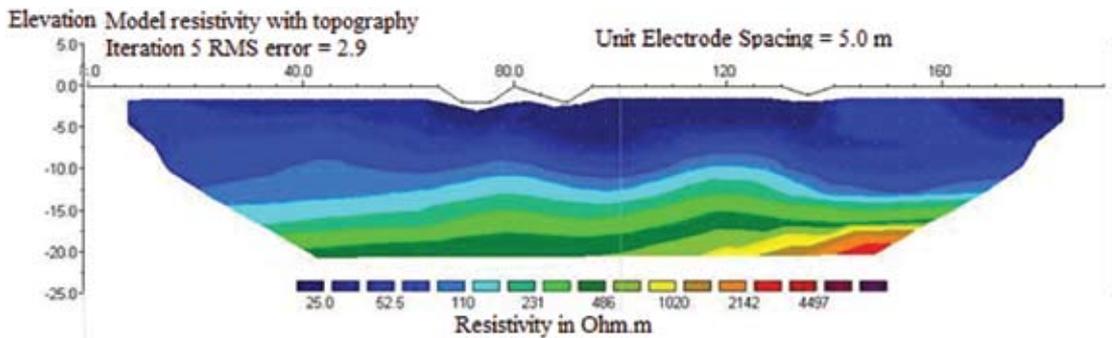
Figure 11

Figures 11 and 12: Resistivity image and SP survey profile respectively for transect T_5W_2

There is no evidence for significant geological structures for the transect T₅W₂. As such, groundwater in this area is likely to accumulate in the top soil layer and not in deep geological structures. This was evident during field inspection of existing wells in this area where they indicated that the water table was less than one metre from the surface. The negative SP anomalies for most of the profile (Figure 12) correspond well with these results. However, the rather high SP anomaly at a distance of about 125 m does not agree with those of the resistivity survey.

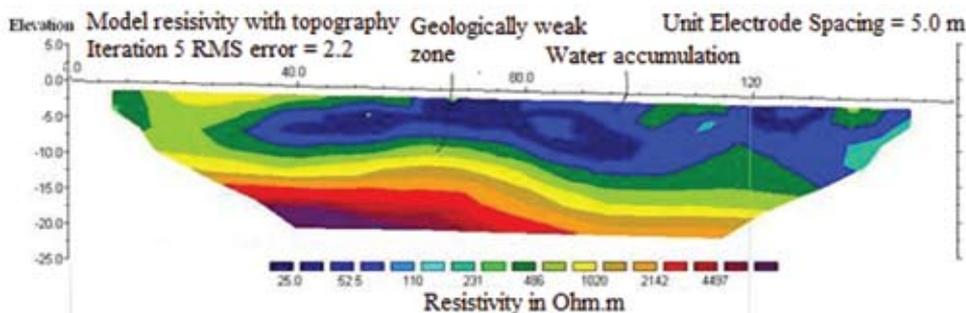
Figure 13

Figures 13 and 14: Resistivity image and SP survey profile respectively for transect S₇W₁

The resistivity profile (Figure 13) and SP anomalies (Figure 14) for transect S₇W₁ indicate areas of low resistivity and negative SP anomalies respectively, thus indicating possible shallow groundwater accumulations. The resistivity image seems to indicate a possible fault at a depth of around 15-20 m, which is not reflected in the SP values.

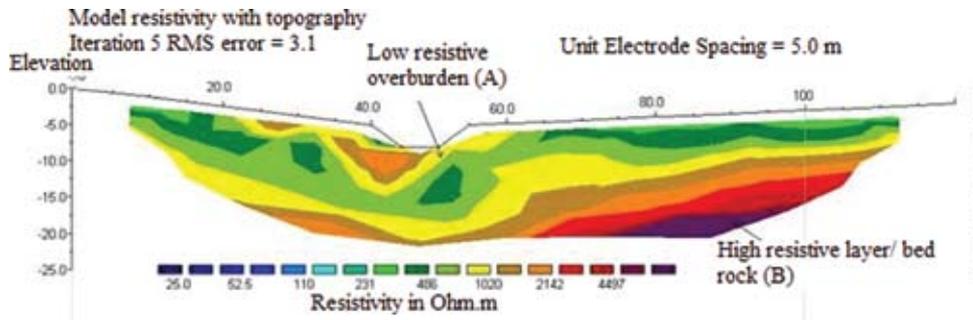
Figure 15

Figures 15 and 16: Resistivity image and SP survey profile respectively for transect S₇W₂

Figures 15 & 16 show the resistivity image and SP anomalies for transect S₇W₂ respectively. As can be seen no significant geological structures are indicated on the resistivity image indicating the unlikely occurrence of structures for groundwater accumulations, which are also

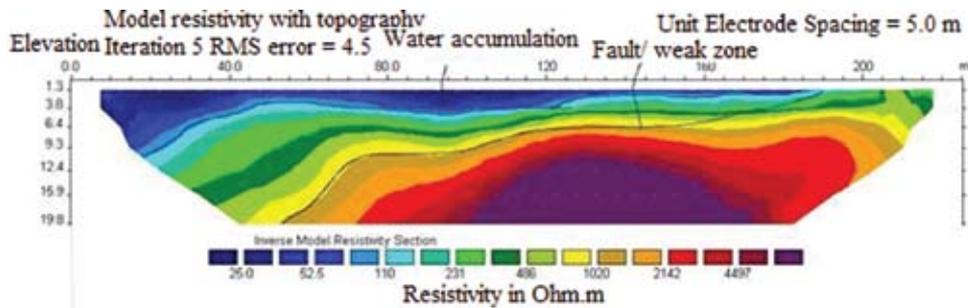
Figure 17

Figures 17 and 18: Resistivity image and SP survey profile respectively for transect S₇W₄

Figures 17 and 18 also show good correlation of results obtained by the two methods for transect S₇W₄ as the low resistivity areas in the resistivity images overlap well with the areas of negative SP anomalies (indicated by P and Q in Figure 18), indicating possible groundwater accumulations. A fault or a weak zone can also be identified from the resistivity image.
